Manhole Inspection Summary

Manhole # S23K__010MH

Insp Date: **6/12/08 12:16 PM**

Location Address: **323-1412 S Norris**

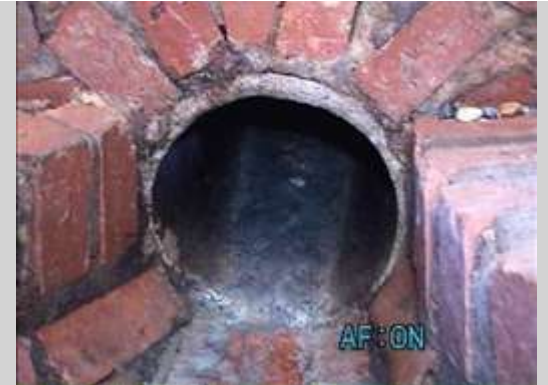
12 O'Clock Outflow

8 in. Circular Gravity Sewer
Pipe Out @ 12 O'Clock

Pipe Height: **8.4** (in.) Rod and Bar (Angled)
Pipe Material: **Clay** ☐ Pipe Lined
Invert Depth: **13.63** (ft.) Flow Characteristics: **Fast**
Deposits: ☒ None ☐ Mud ☐ Sludge ☐ Debris ☐ Grease
Silt Depth: **0** (in.) Deposits Extent:
Infiltration: **None** Pipe Seal Cond: **Sound**

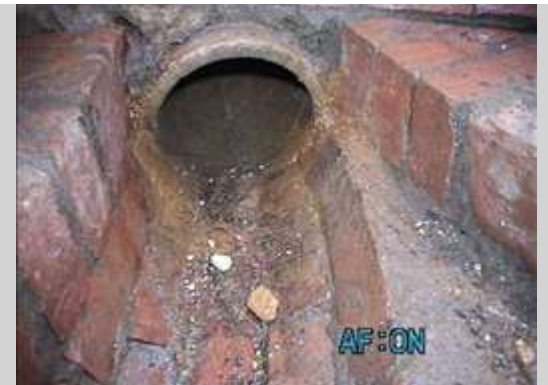
4 O'Clock Inflow

6 in. Circular Gravity Sewer
Pipe In @ 4 O'Clock

Pipe Height: **6** (in.) Rod and Bar (Angled)
Pipe Material: **Clay** ☐ Pipe Lined
Invert Depth: **13.01** (ft.) Flow Characteristics: **None**
Deposits: ☒ None ☐ Mud ☐ Sludge ☐ Debris ☐ Grease
Silt Depth: **0** (in.) Deposits Extent:
Infiltration: **None** Pipe Seal Cond: **Sound**

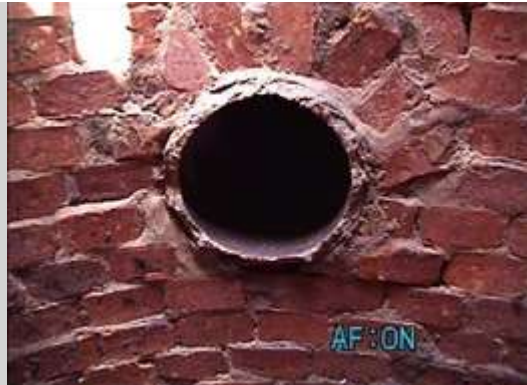
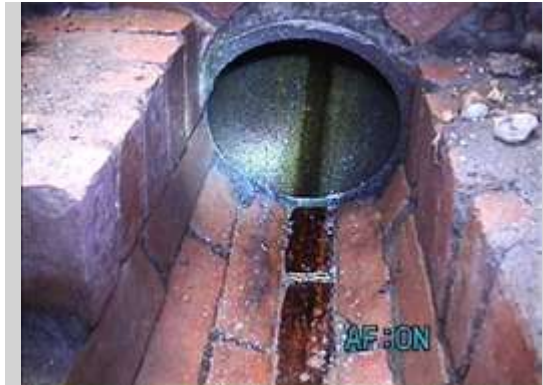
6 O'Clock Inflow

8 in. Circular Gravity Sewer

Pipe In @ 6 O'Clock

Drop In @ 6 O'Clock

Drop: Inside	Rod and Bar
Angled: Yes	Reading: 12.24 (ft.)
	Inv Depth: 13.24 (ft.)
Drop Condition: Open

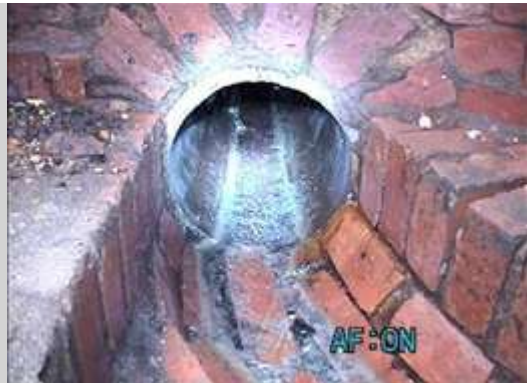
9 O'Clock Inflow

8 in. Circular Gravity Sewer

Pipe In @ 9 O'Clock

Infiltration: **None** Pipe Seal Cond: **Sound**
